Monitoring Data Record

Project Title: B-3157 (Michael's Branch Site) COE Action ID: 200020843

Stream Name: Michael's Branch

City, County and other Location Information: Davidson County, Bridge #74 & #76 over SR 1242 and Michael's Branch and approaches on US 29/64/70 & I-85 Business.

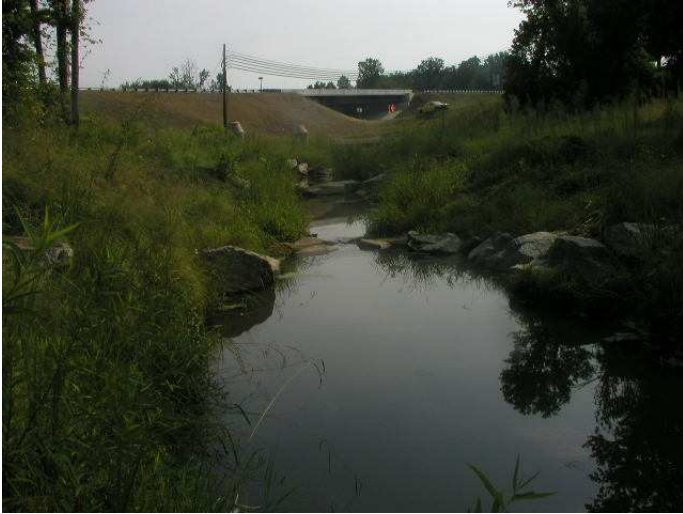
Photo Point #4 (Upstream)

There were dead plantings noted between the outlet end of the double barrel box culvert downstream to PP#4.

Estimated causes, and proposed/required remedial action: The area noted above will be replanted in 2009.

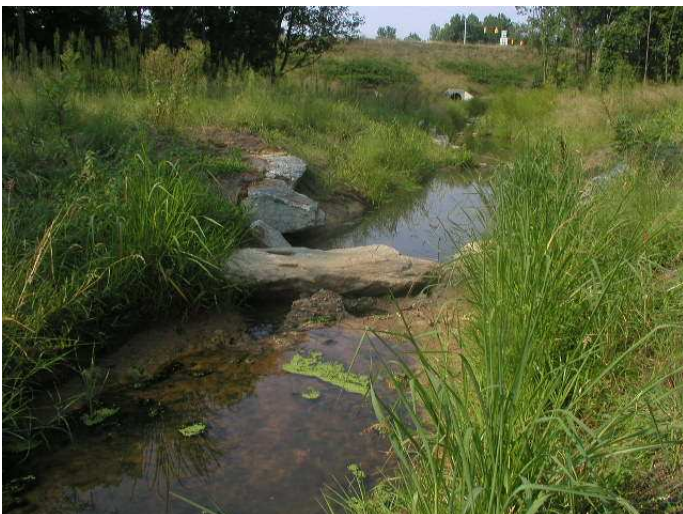
Michael's Branch has experienced several bankfull events since the last monitoring evaluation. These bankfull events have caused a crossvane below the double barrel box culvert to fail (photo attached @ the end of the photo sequence). Another crossvane downstream has some erosion at the end the right arm. NCDOT is planning to take remedial action as soon as possible. Other than these two areas the remaining portion of the stream relocation is stable.

Date 8/15/08	Upstream of PP#4	Downstream of PP#4	Station Number	Station Number	Station Number
Structure Type	Crossvane	Crossvane			
Is water piping through or around structure?	Water is piping under crossvane				
Head cut or down cut present?	Headcut				
Bank or scour erosion present?		Erosion @ the end of the right arm			
Other problems noted?

(Crossvane failure upstream of PP#4)
